2009 Survey of Aquatic Plants in Martins Pond

Prepared by:

Jonathan Lyon, Ph.D.

AUGUST 2009

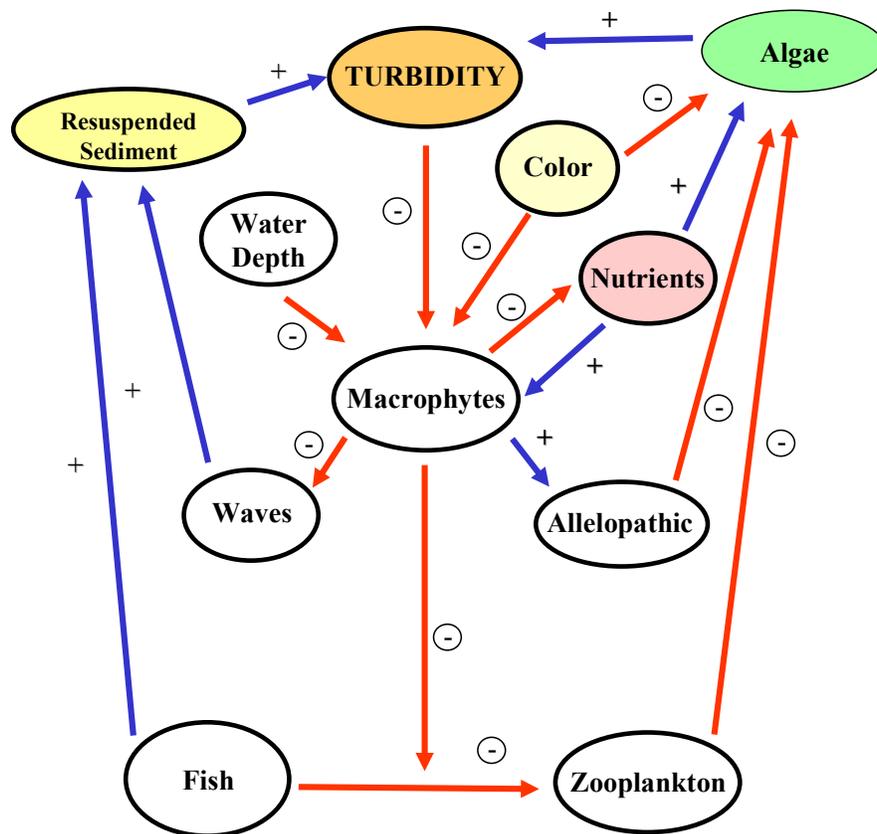
Figure 1. A summary of interrelationships between aquatic plants (macrophytes) and other factors in shallow eutrophic systems such as Martins Pond.

A summary of the interconnections and feedbacks between turbidity, color, nutrients and other critical components of shallow eutrophic lakes (such as Martins Pond) are shown in Figure 1. Management efforts that alter turbidity, nutrients, macrophyte or other components shown in the Figure, will have repercussions on the entire system. For example, any significant reductions in turbidity will likely result in increased macrophyte growth, expansion of the littoral zone and increased susceptibility to algal blooms. Such a result might ultimately be counter to the objective of improving the recreational potential of Martins Pond.

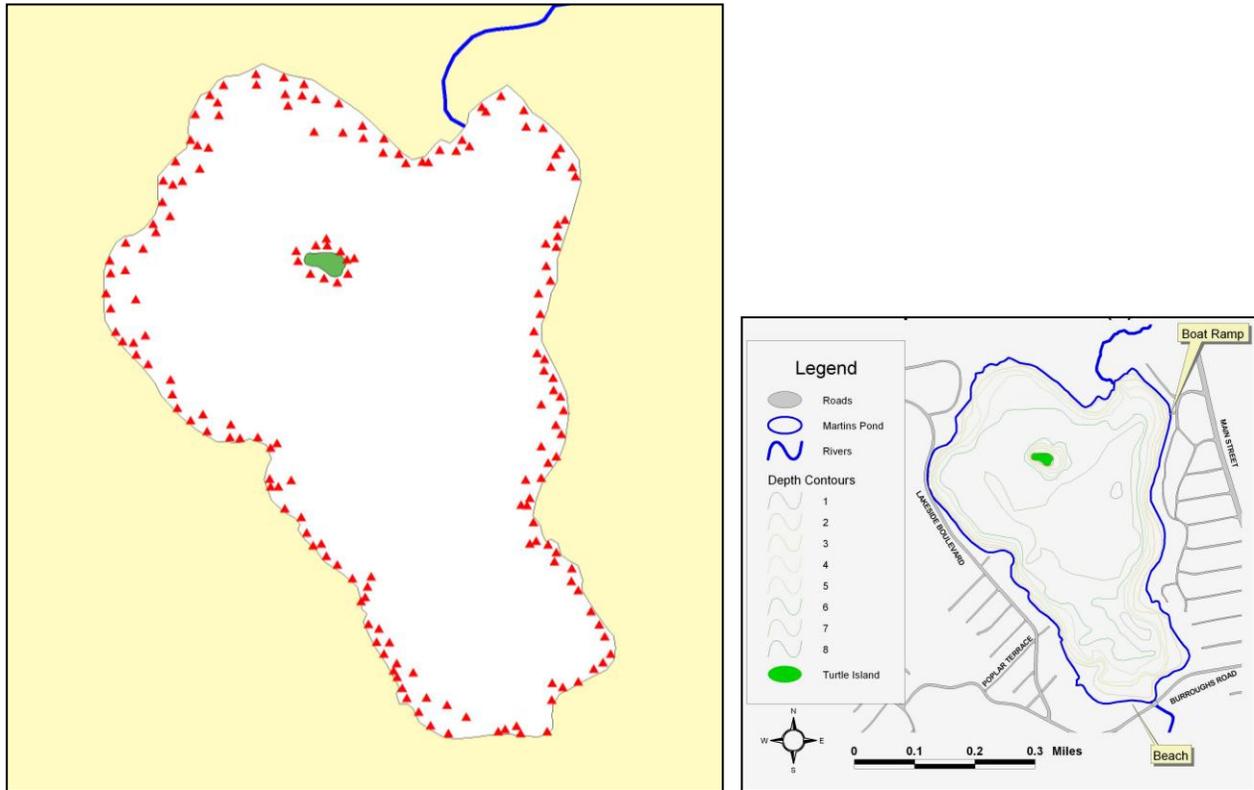
Figure 2. The location of aquatic plant sample points (red triangles) for the 2009, 4-year-post-harvest survey are noted in the larger figure on the left. Data from a total of 179 sample points was collected, with 122 sample points having at least some macrophytes present. The smaller figure on the right is a bathymetric map of Martins Pond generated in 2007.

Figure 2 shows the location of all the sample points for the 2009 macrophyte survey. A similar distribution of aquatic plant sample points was used in all the previous aquatic plant surveys conducted by Merrimack College.

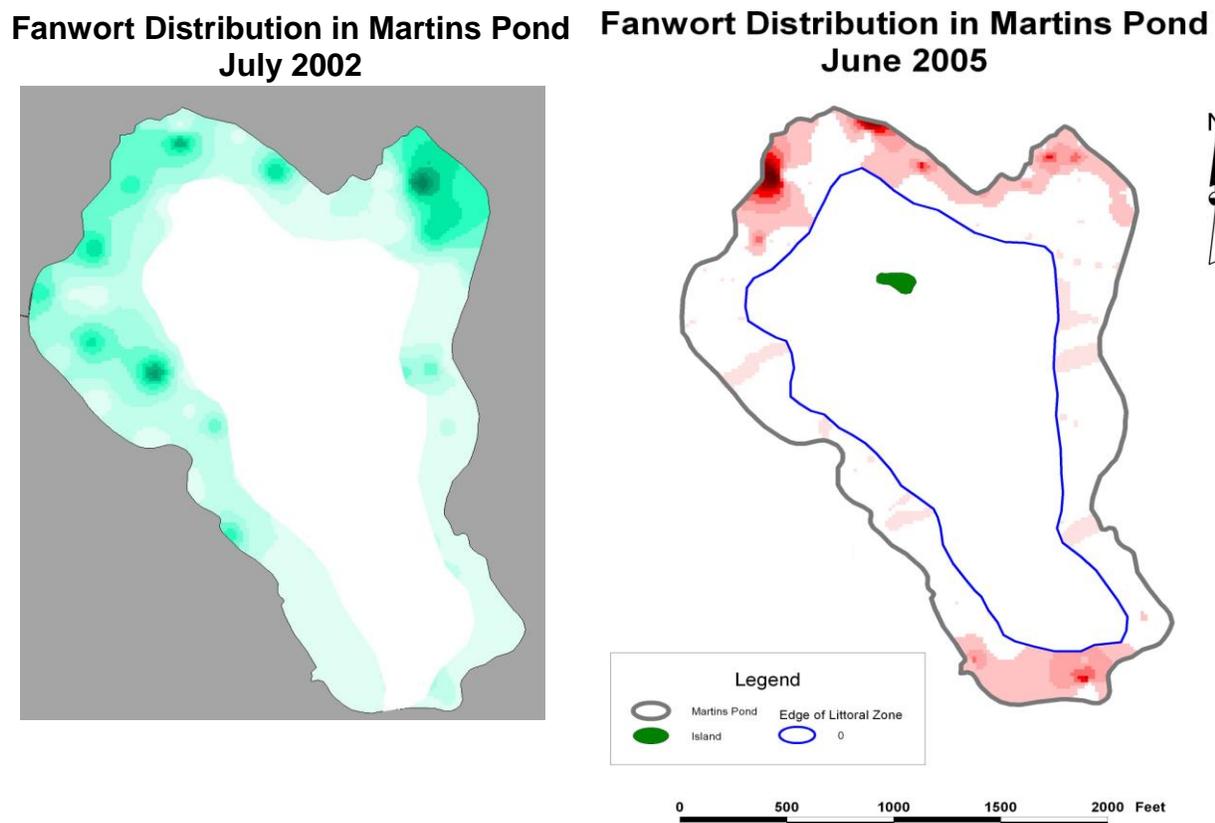
Fanwort abundance has exhibited a pattern of changing abundance and distribution from year to year in Martins Pond. Figure 3 provides a comparison of the abundance and distribution of fanwort in 2002 and in 2005 in Martins Pond. The original impetus for the 2005 harvesting program was the high density of fanwort observed in 2002 (Lyon and Eastman, 2006). However, by 2005 both the distribution and abundance of fanwort had decreased substantially (see Table 2). Similar short-term changes in fanwort abundance were noted in the IEP (1977) study. They cited pond surveys in 1968 and 1969 by the Department of Environmental Quality Engineering. The 1968 and 1969 surveys indicated high density and widespread distribution of fanwort in the littoral zone. However, by 1976, fanwort density was substantially lower.

Figure 3. A comparison of fanwort distribution and abundance in Martins Pond in 2002 (left) and 2005 (right). Darker shades of green (2002) and red (2005), represent higher densities of fanwort. The 2005 distribution represents conditions prior to mechanical harvesting.

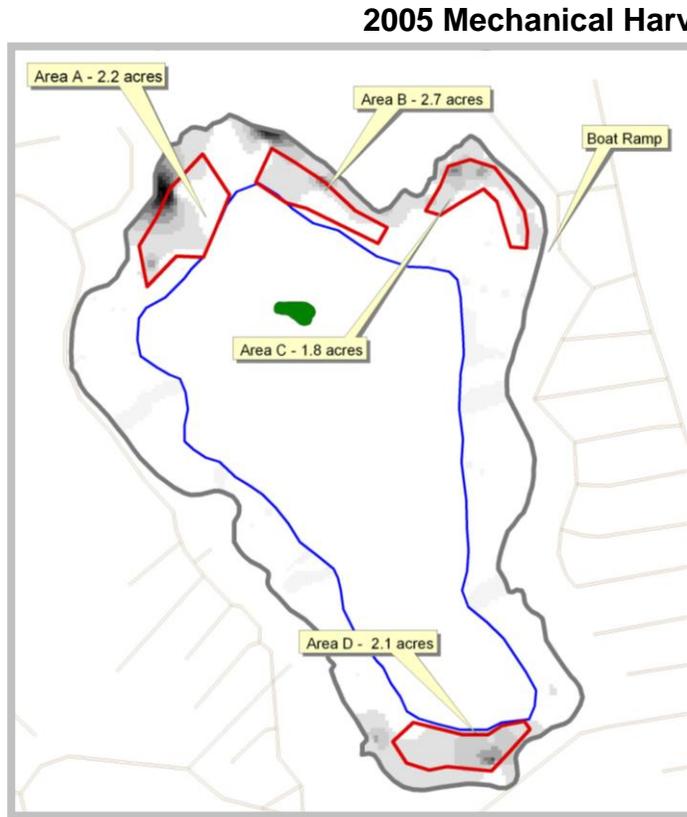
Figure 4 shows the 2005 mechanical harvesting map for Martins Pond. All Areas with the exception of Area A (2.2 acres) were harvested in 2005.

Figure 4. The harvesting map created for Aquatic Control Technology Inc., to guide their mechanical harvesting in July 2005. A total of four harvesting areas (in red) were proposed. The total proposed harvesting area was approximately 8.8 acres (9.4% of the pond's area). The extent of the littoral zone is shown by the blue line. All Areas except Area A were harvested in 2005.

- The abundance of fanwort in the non-harvested Area A (see Figure 4 for location) during the entire study period suggests that fanwort abundance may be increasing cyclically, independent of the impact of harvesting. The low levels of fanwort in 2006 and 2007 in Area A and the increase in fanwort in 2008 and 2009, point to factors other than harvesting that are contributing to both fanwort decline and increase.

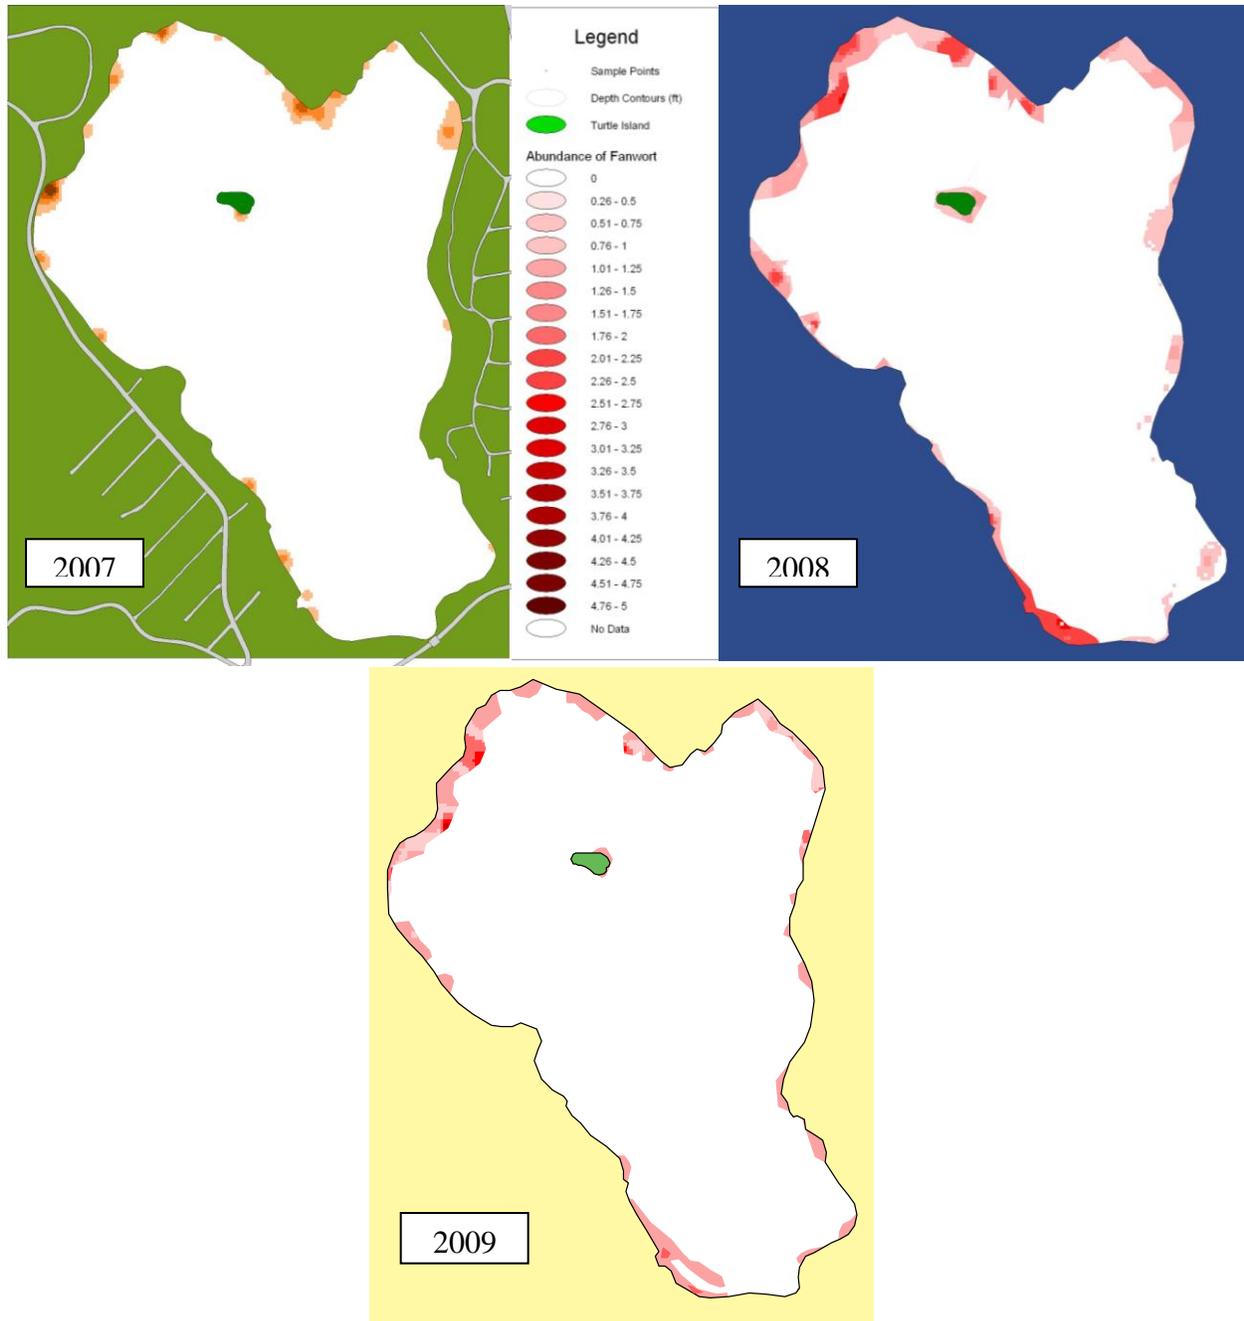
Post-Harvesting Fanwort Distribution – Figure 5 shows the abundance and distribution of fanwort based on the 2007, 2008 and 2009 survey results. Overall, there was an increase in both the extent and abundance of fanwort in Martins Pond relative to 2007 levels (and 2006), but still lower than the pre-harvest levels observed in 2005. The abundance of fanwort in the non-harvested Area A (see Figure 4 for location) in 2008 and 2009 also showed increased abundance despite not being harvested. This suggests that fanwort abundance may be increasing cyclically independent of any harvesting effect. In any event, the extent and abundance of fanwort was very similar to that observed in 2008.

Figure 5. The abundance and distribution of fanwort (*Cabomba caroliniana*) based on the 2007 (upper left), 2008 (upper right) and 2009 (lower center) survey results. Fanwort abundance is based on a 0 to 5 abundance scale with increased density correlated with darker red colors. It is clearly evident that the abundance and spatial distribution of fanwort increased in 2008 relative to 2007. However, 2009 abundance was very similar to the 2008 both in relative density and distribution. In all three sample years, fanwort exhibited a patchy distribution with a higher density of fanwort along the shorelines, particularly in the northern half of Martins Pond.

- Given both the relatively low abundance and extent of fanwort in Martins Pond in the summer of 2009, especially given its relative similarity to the 2008 survey, no additional harvesting or management activities to control fanwort are recommended at this time.

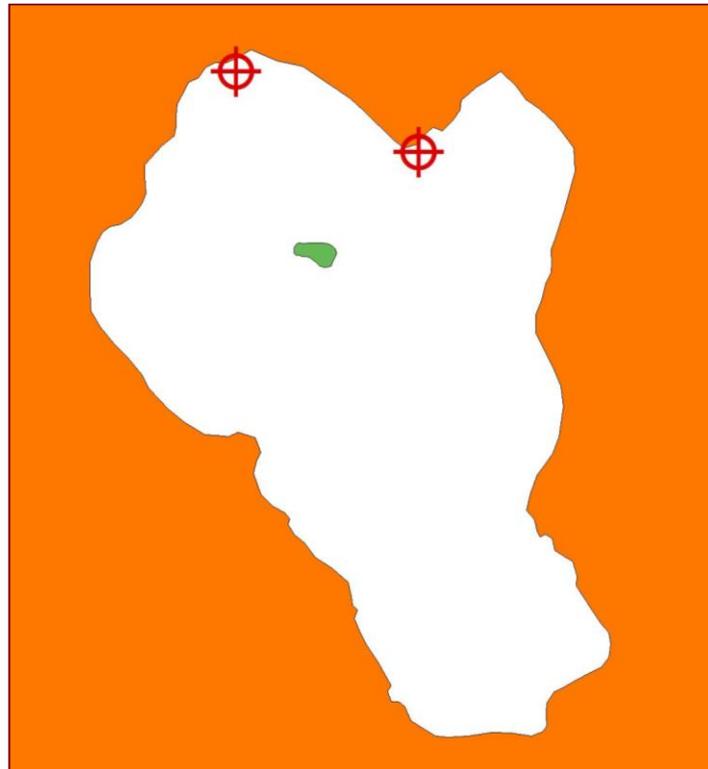
Two new small patches of water chestnut were found in Martins Pond for the first time in 2009. Figure 6 below shows the locations of the two confirmed patches of water chestnut. The species is currently restricted to only these two areas. A detailed canoe survey was conducted along the entire shoreline of the pond to ensure that any water chestnut plants were observed and mapped.

Figure 6. The locations of the two isolated patches of water chestnut found in the 2009 survey are noted by the red circle-crosses. The plants, while currently limited in population size in two regions in the northern shoreline of the pond, are mature and reproductive.

It is **highly recommended that immediate action** be taken to carefully harvest all the existing plants and that there be continued monitoring to track any occurrences and locations of this new invasive species.

- The new outbreak of water chestnut in the northern region of Martins Pond needs to be dealt with immediately. Hand harvesting of all plants should occur as soon as possible.
